NASA TN D-3409

# MECHANICAL AND PHYSICAL PROPERTIES OF THE ECHO II METAL-POLYMER LAMINATE

*by C. L. Staugaitis and L. Kobren*

*Goddard Space Flight Center  
Greenbelt, Md.*

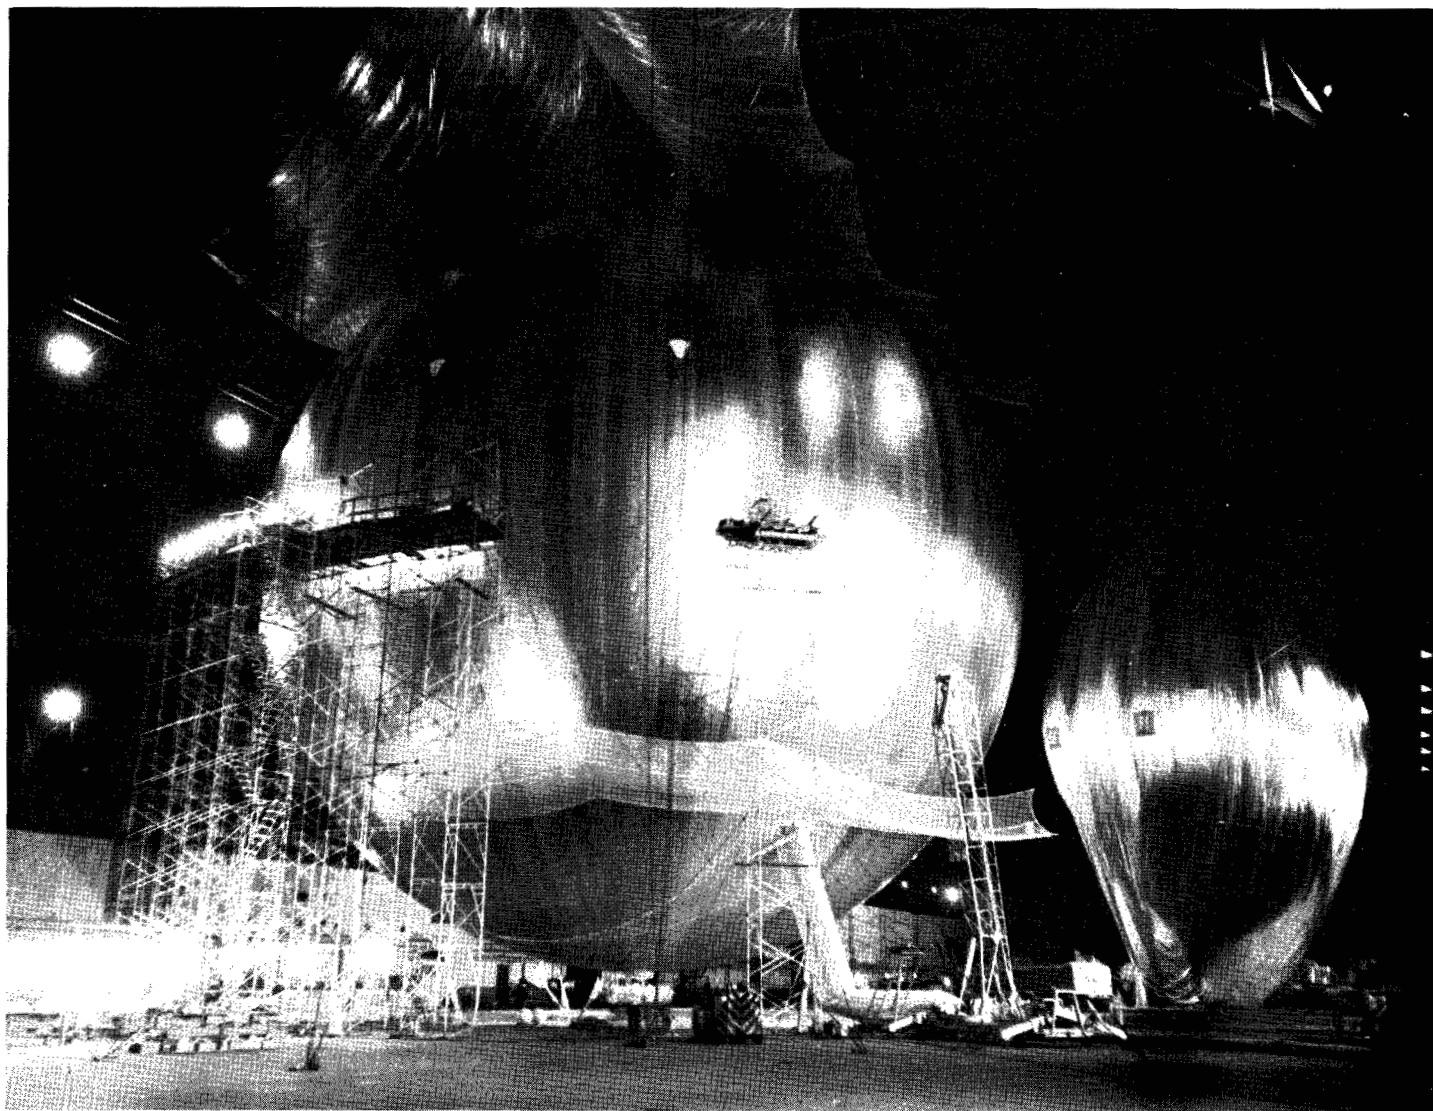
Overall view of static inflation tests conducted at Lakehurst, N.J., 1963.

Methods for maintaining balloon stability, programmed inflation rate, and constant lift were devised and successfully implemented at the Lakehurst Test Site. The method used for maintaining a minimum (near-neutral) buoyancy depended on obtaining a minimum difference in density between the ambient air and the air within the balloon. Intake and exhaust ports were provided so that ambient air could be circulated within the balloon. Two exhaust ports, one at the top and one at the bottom of the balloon, provided for the dumping of cold air (bottom) and warm air (top) to obtain the required buoyancy. Pressure in the balloon was maintained at any desired level with automatically controlled dampers on the inlet and exhaust ports which regulated the amount of ambient air that was introduced into the balloon. Heaters at the inlet ports supplied warm air to the balloon when extra lift was necessary. An overall view of the test set-up is shown in the frontispiece.
